**BUJAGALI HYDROPOWER & INTERCONNECTION
PROJECT**

10th Site Visit August 29 to September 1, 2012

PANEL OF ENVIRONMENTAL AND SOCIAL EXPERTS

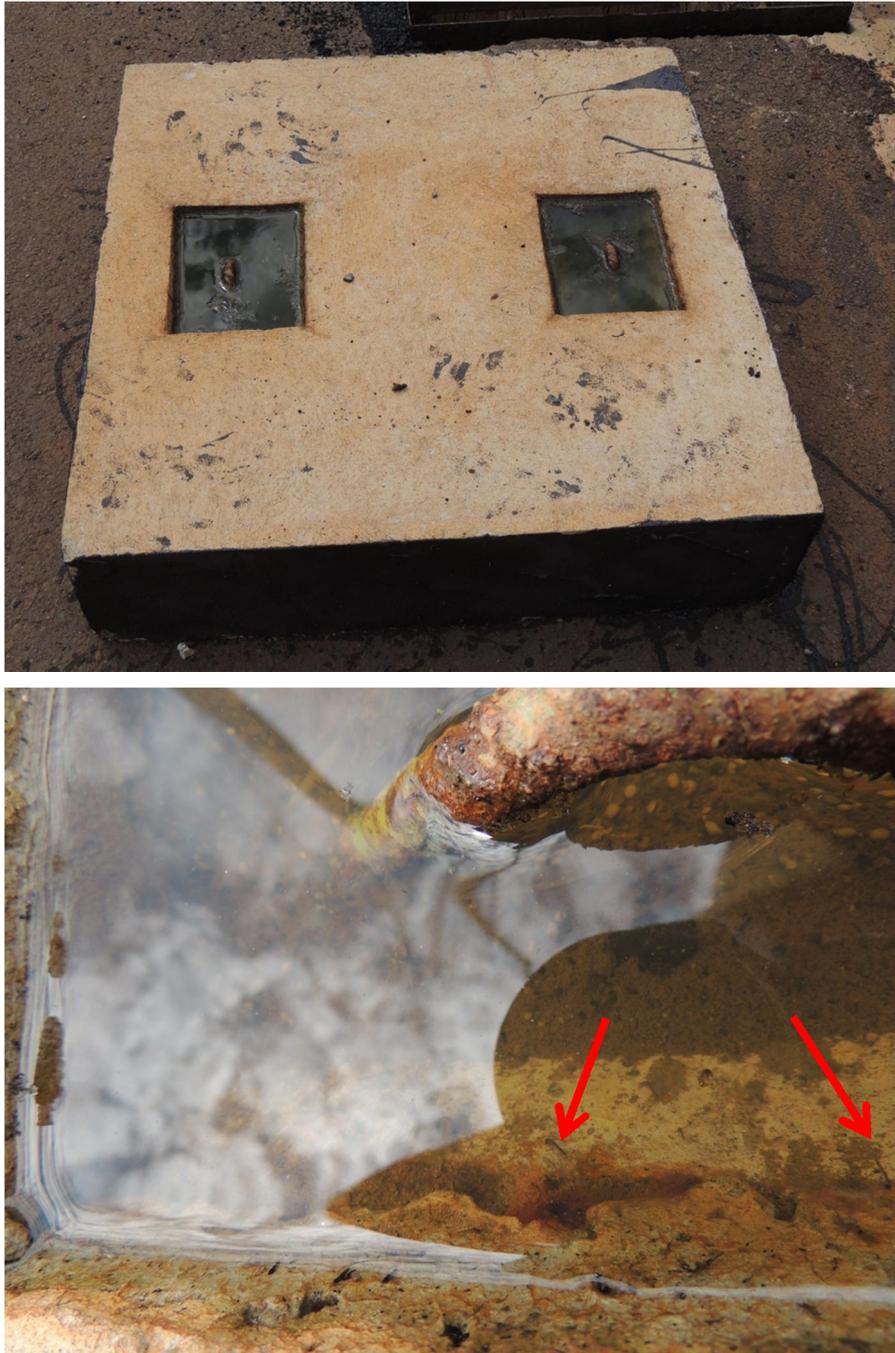
Each of these slabs shows one (the smaller ones) or two (the larger ones) hollows with a metal hook which allows to remove them (see picture below). Each of these hollows, at

the time of the site visit was filled with water, and most of them were inhabited by mosquito larvae.

This means that the street lighting provides a very good breeding habitat for mosquitos, at least during the rainy season.

Figure 2-1: Slab with hollows filled with water (upper picture), mosquito larvae (lower picture, two larvae indicated by arrows)

One rather simple way to prevent this would be to cut a "drainage channel" from each of these hollows to the nearest edge of the slab, in order to prevent water from accumulating there.
